ROFU 8406M Sliding Door Magnet Installation Instructions

This unit is 12/24VDC

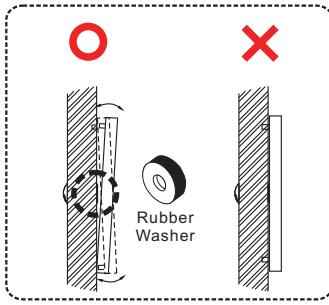
Installation Diagram

Three rubber washer makes the armature plate float in order to reach proper combination with the magnetic lock.

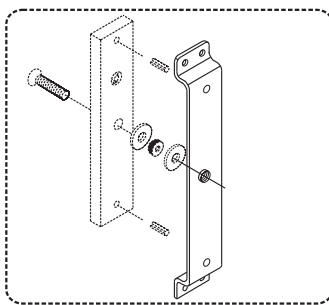
#20925 Armature Bracket (optional for ROFU 8406M)

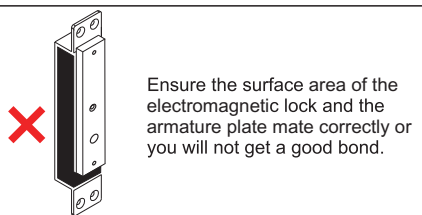
The 8406M requires a face-to-face alignment as shown in the far left figure. This magnet is NOT designed as a Shear Lock.

Ensure the surface area of the electromagnetic lock and the armature plate mate correctly or you will not get a good bond.
